Thame Town Council - Town Hall

Condition Report

Issue: 08.04.20204

Commission Number: 23.035

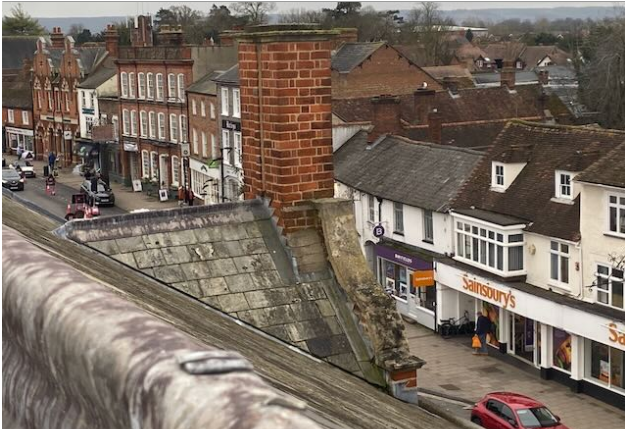
1	1	1.4	Roofs	Roofs structure	Coping stones	B	2	01	Cyclical	£0.00	£0.00	£0.00	£0.00	£0.00	£0.00	£0.00	Generally found to be in satisfactory condition however evidence of moss, lichen and guano build up which is common for stones of this age and requires cleaning down in the next 2
1	1	1.5	Roofs	Roof coverings and insulation	Tiles	C	1	02 03	Repair	£30,000.00	£0.00	£30,000.00	£0.00	£0.00	£0.00	£0.00	Natural slate covering present to the pitched roof generally found to be in satisfactory condition and performing as intended however evidence of moss and lichen growth indicating slate coverings are becoming porous and retaining moisture; this should be cleaned down and treated with an anti fungal treatment. Elsewhere there are signs of dislodged/defective tiles which should be repaired/replaced as these currently present a serious health and safety risk to the general public. Note: Due to the high cost of access for clean down/treatment and isolated tile repairs/replacement tiles, you may wish to consider a full renewal of roof coverings with a budget of c.£80k.

01. Moss, lichen and guano build up to coping stones.

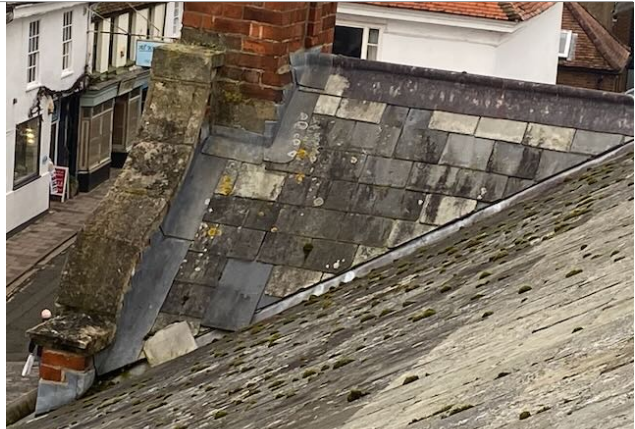
02. Slipped/dislodged tiles to dormer.

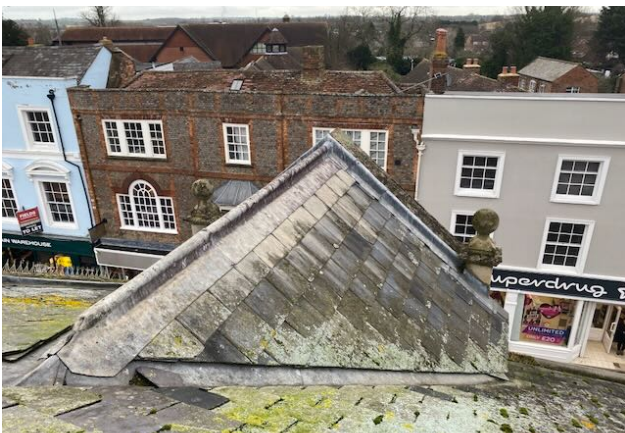
03. Moss, lichen and guano build up to slate roof coverings.

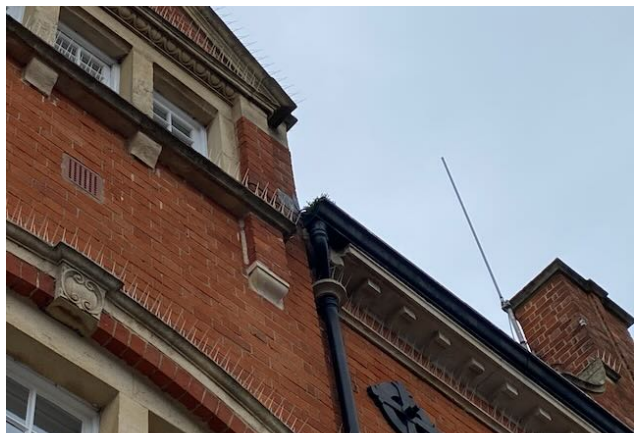
04. Vegetation growth to guttering.

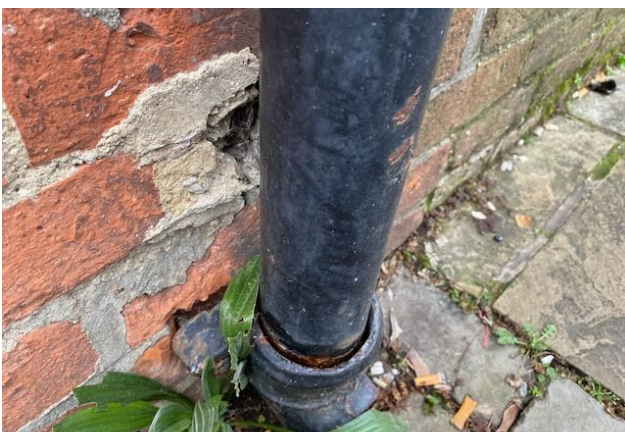
05. Vegetation growth and corrosion present at base of downpipe.

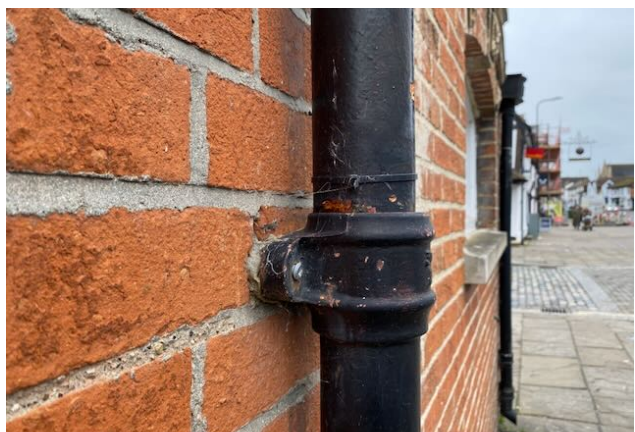
06. Corrosion present to downpipes.

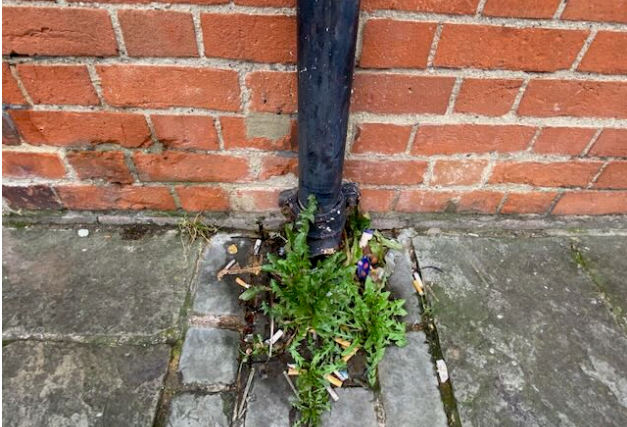
07. Vegetation preventing rainwater draining effectively.

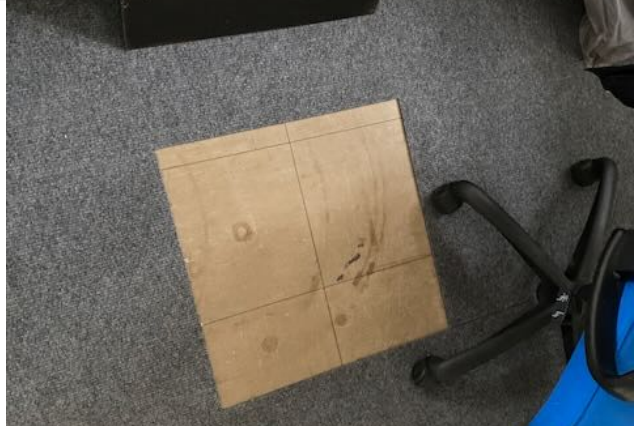
08. Missing Carpet tile to top floor office.

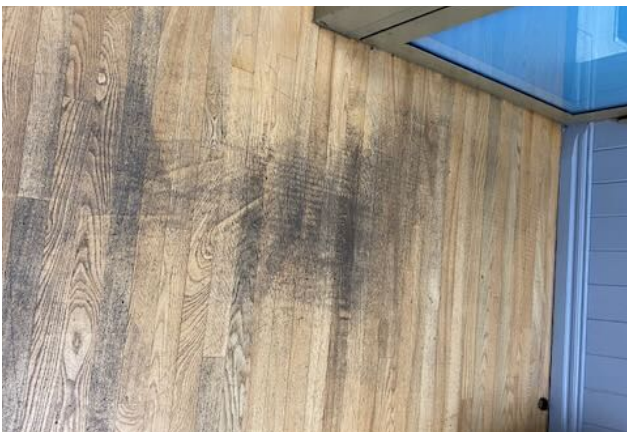
09. Worn flooring to Town Hall entrance.

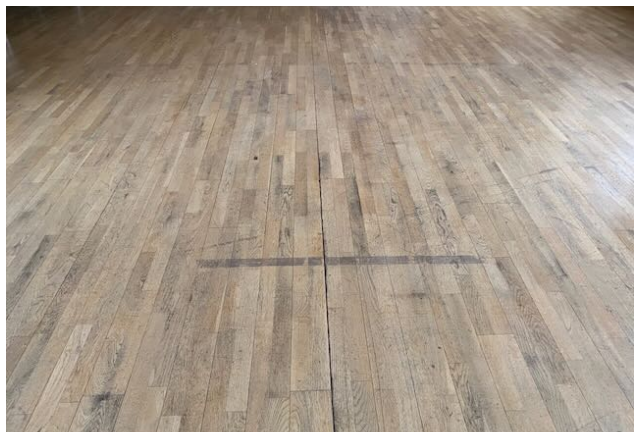
1	2	2.4	Floors and stairs	Floors screed and finish	Timber floor	C	2	10	Investigate	£500.00	£500.00	£0.00	£0.00	£0.00	£0.00	£0.00	During the inspection it was reported that the timber flooring in the 'Chambers room' swells and lifts in the middle of the room. At the time of the assessment there was no obvious signs of floor lift or trip hazard present. Recommend monitoring/investigating when lifting movement occurs.
1	2	2.5	Floors and stairs	Staircases structure	Concrete	B	4	N/A	No action required	£0.00	£0.00	£0.00	£0.00	£0.00	£0.00	£0.00	Concrete formed staircase from ground to first floor concealed by vinyl floor coverings however no obvious signs of defects/distress.
1	2	2.6	Floors and stairs	Staircases balustrades	Metal	B	4	N/A	No action required	£0.00	£0.00	£0.00	£0.00	£0.00	£0.00	£0.00	Painted metal balustrades appear in satisfactory condition. Routine maintenance required to maintain aesthetics and structural integrity.

10. Reported lifted flooring to the chamber not observed during inspection.

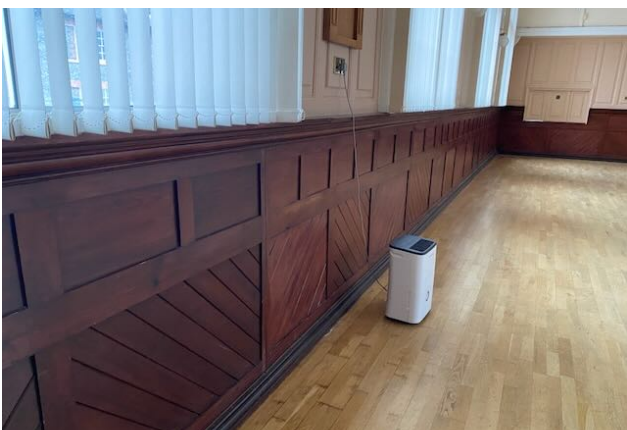
11. Minor defects to timber cladding in the chambers.

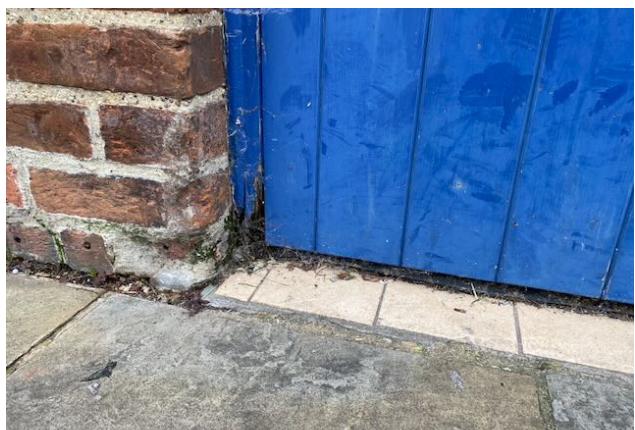
12. Rot present to external timber door frame.

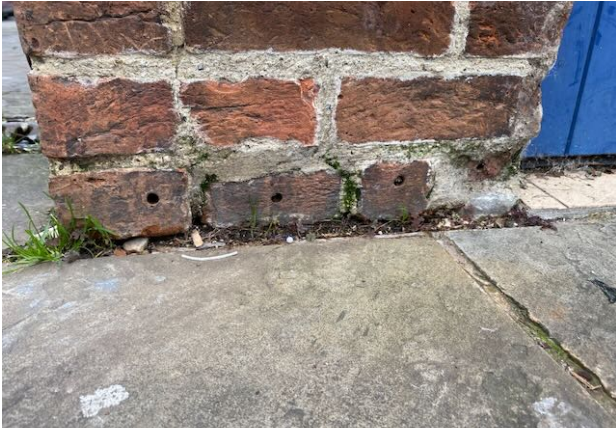
13. Evidence of previous damp proof injection works having been carried out.

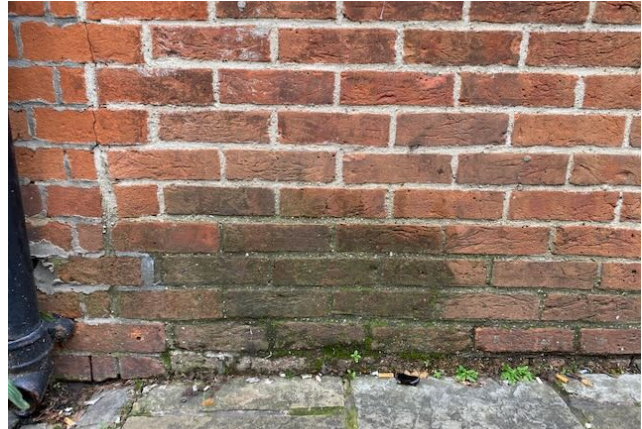
14. Evidence of saturated brickwork.

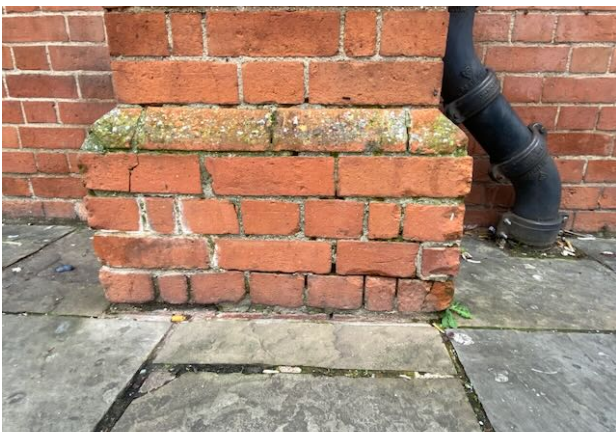
15. Loose/defective mortar jointing.

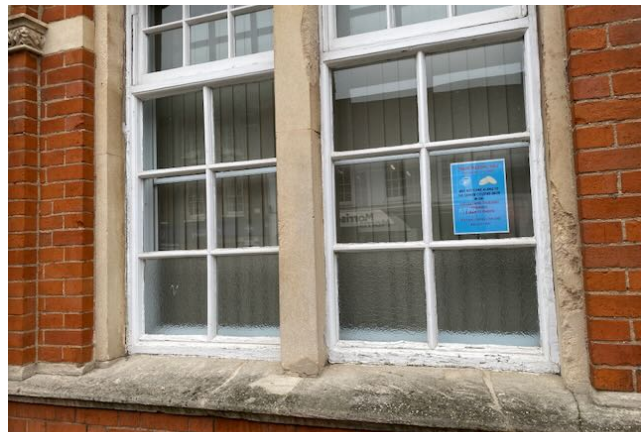
1	4	4.2	External walls, windows and doors	External walls external finishes	Cills, columns	C	2	16 17	Repair	£0.00	£0.00	£0.00	£0.00	£0.00	£0.00	£0.00	The majority of the stone window reveals, cills and columns are in satisfactory condition however there are numerous areas of spalled/eroded stone evident indicating these have become porous. A cost for necessary repairs to defected stone has been included in item 4.1.
1	4	4.3	External walls, windows and doors	External windows and doors	Windows	C	2	18	Cyclical	£15,000.00	£0.00	£15,000.00	£0.00	£0.00	£0.00	£0.00	Painted timber single-glazed sliding sash windows are generally in fair condition however the majority of windows are showing signs of failed/worn decorations. There is a crack to a low-level window which may be at risk increasing in size during the winter months. It was advised windows were operational; routine maintenance shall be required to ensure windows remain operational. Numerous window reveals are showing signs of missing/defective mortar and is a likely source of water ingress and may affect the thermal performance of the property. A cost for redecoration and putty repairs has been included in year 1; high level access costs have been allocated in item 1.5 as part of the roof repairs and guttering clearance.

16. Spalled stone window reveals in need of repairs.

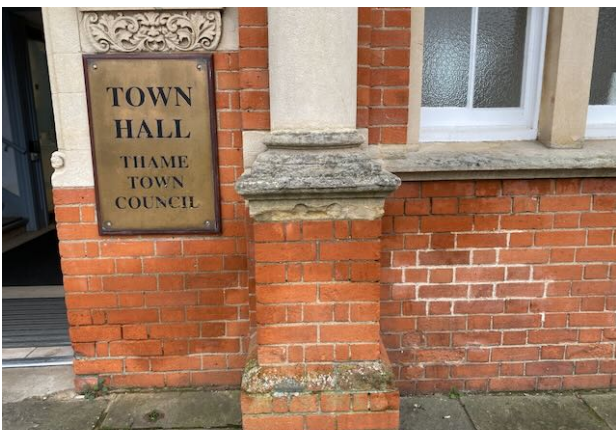
17. Evidence of saturated brickwork and stone detailing in need of repair.

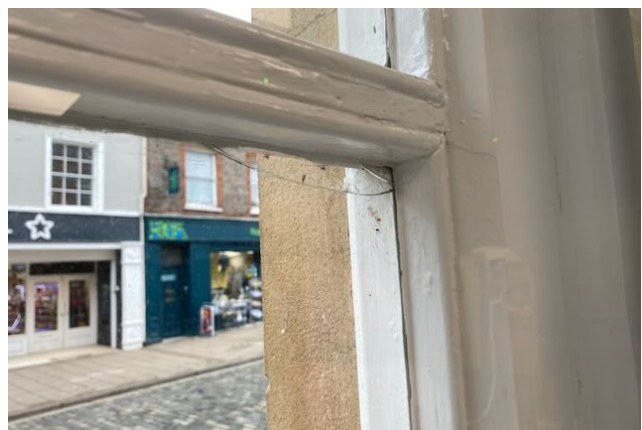
18. Crack in glazing on the ground floor.

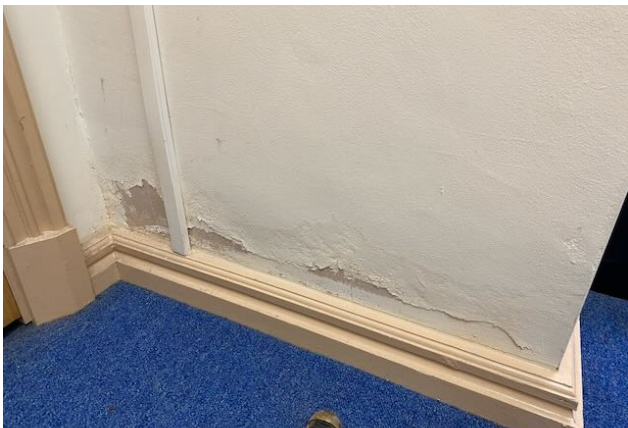
19. Delaminating paint to masonry wall in Reception.

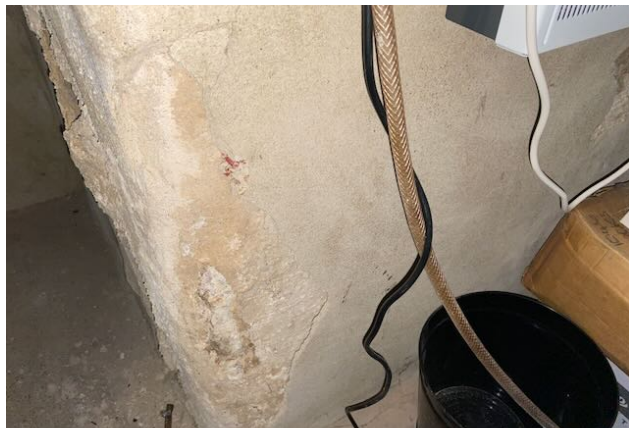
Internal walls and doors	Internal walls and partitions structure	Basement, render	C	2	20 21 22	Investigate	£1,000.00	£1,000.00	£0.00	£0.00	£0.00	£0.00	£0.00	The basement is suffering from a lack of climate control and ventilation resulting in delamination of the internal render and corrosion to the ceiling supporting steel beams. It is recommended that a structural engineer is engaged to assess the condition and structural integrity of the steels and a specialist basement contractor to assess the basement and recommend remedial works.
1	5	5.2	Internal walls and doors	Internal walls and partitions finishes	plaster, plasterboard	B	4	N/A	Cyclical	£0.00	£0.00	£0.00	£0.00	£0.00	£0.00	£0.00	Painted plaster/plasterboard internal wall generally in satisfactory condition.
1	5	5.3	Internal walls and doors	Internal walls and partitions finishes	Timber cladding	B	4	N/A	Cyclical	£0.00	£0.00	£0.00	£0.00	£0.00	£0.00	£0.00	Timber wall cladding generally in satisfactory condition. Isolated areas of defects/damage in the 'Chambers' room. Routine maintenance and treatment of all timber finishes required.

20. Delaminating render to basement

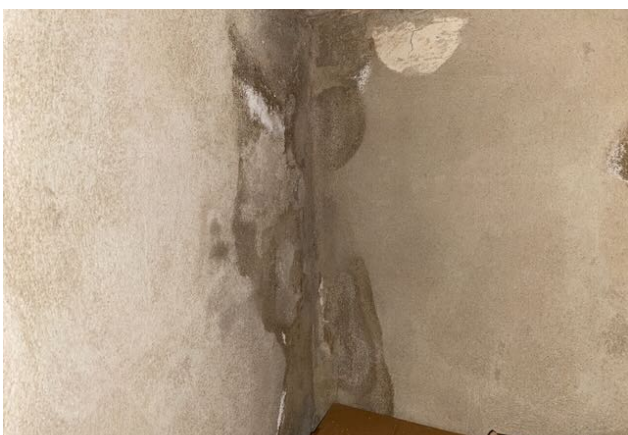
21. Moisture penetration to basement.

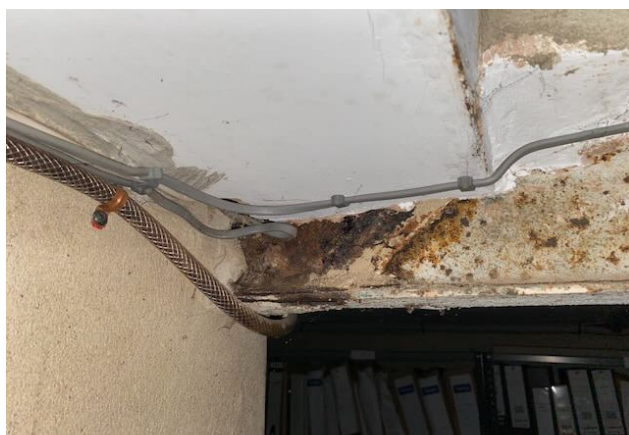
22. Corrosion evident to steel supports in basement.

- A CCTV drainage survey/jetting of rainwater outlets is recommended to ensure they are free from obstruction and running clear
- Potential to introduce ventilation to basement will improve air quality and reduce condensation.
- Structural Engineer to assess the condition and performance of corroded steel lintels in the basement and recommend necessary remedial or repair works.

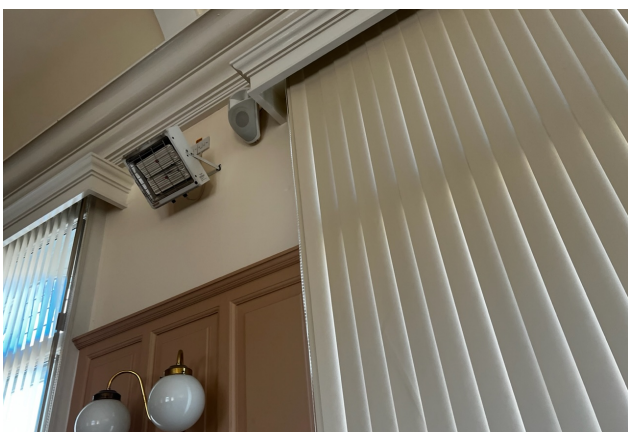
ME01. Electric radiant heaters due for replacement.

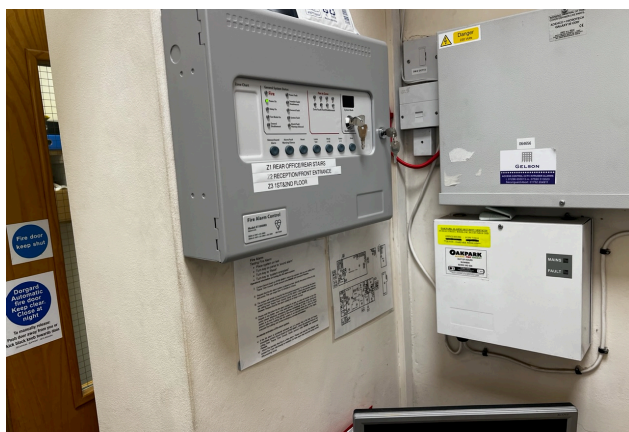
ME02. Fire alarm system approaching the end of life.

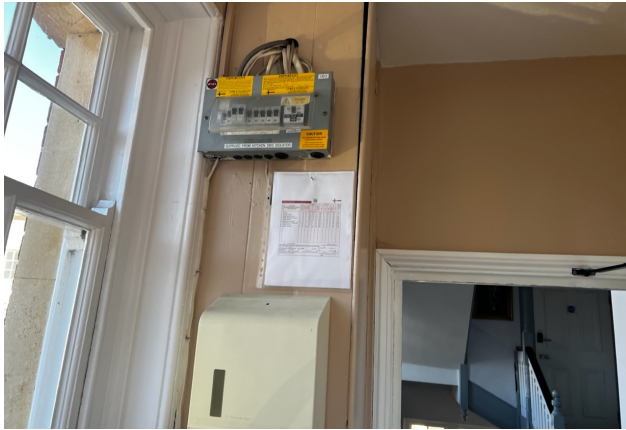
Block ref.	Element No.	Item No.	Element	Sub-Element	Item	Condition	Priority	Photo No.	Action	Total Cost	Year 0 (Immediate)	Year 1	Year 2	Year 3	Year 4	Year 5	Description
1	8	8.2	Electrical services	Power	Wall mounted switchgear	B	4	ME03	Replace	£4,500.00	£0.00	£0.00	£0.00	£4,500.00	£0.00	£0.00	Distribution boards and MCB boards in reasonable condition albeit the basement board and kitchen distribution boards would benefit from replacement during the term.
1	8	8.3	Electrical services	Lighting system	Linear and compact fluorescents	C	3	N/A	Replace	£6,000.00	£0.00	£0.00	£0.00	£2,000.00	£2,000.00	£2,000.00	The lighting is on the whole LED fluorescent remain installed to the entrance lobby and concealed in the perimeter of the chamber, as fluorescents have limited product support. A rolling programme of replacement is recommended.
1	8	8.4	Electrical services	Alarms	Intruder detection and fire alarm system	C	3	ME02	Replace	£9,500.00	£0.00	£0.00	£0.00	£0.00	£0.00	£9,500.00	The fire alarm system will be approaching the end of its life factor during the term and consideration to replacement head end and devices should be considered during the term.

ME03. Distribution boards due replacement.
