Six Property Consulting

Thame Maintenance Depot

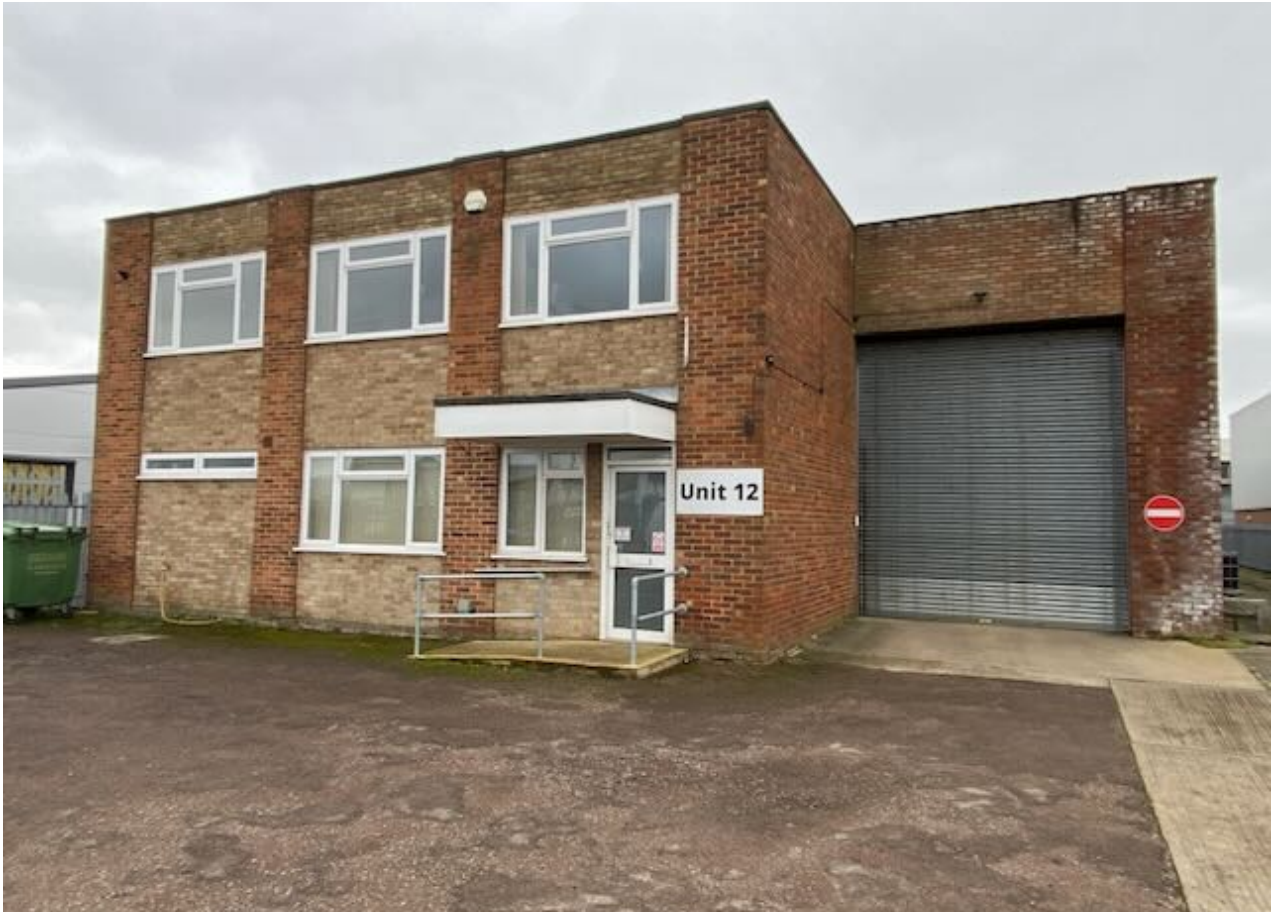
Prepared for: Thame Town Council

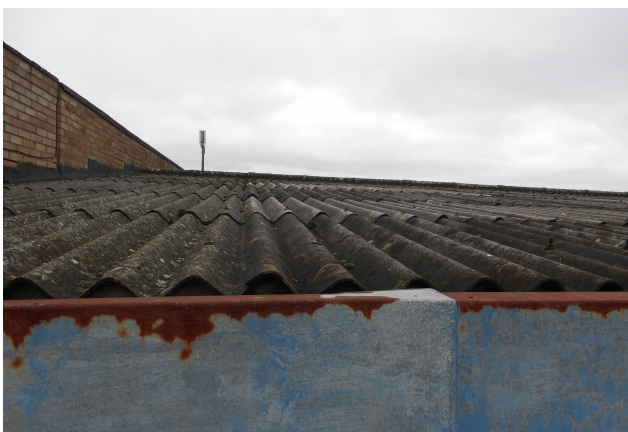
05: Corrosion to metal fascia sheets.

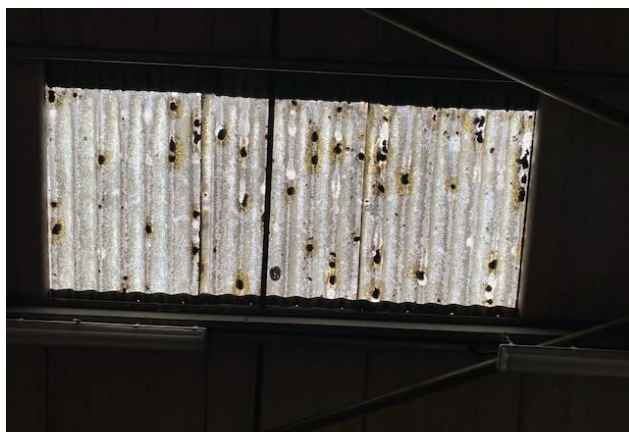
06: Discolouration and moss build up to rooflight above warehouse.

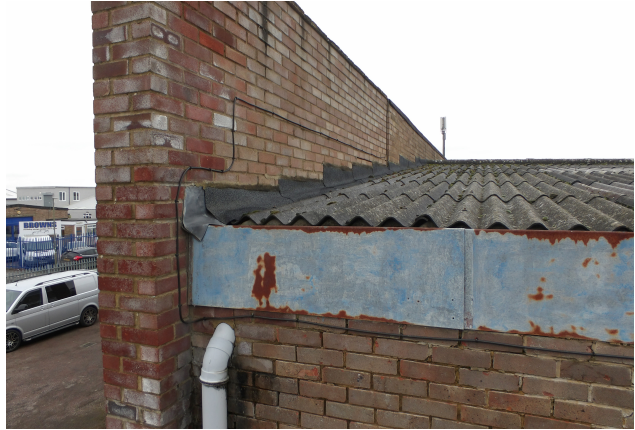
08: Failed downpipes and corroded metal fascia sheets.

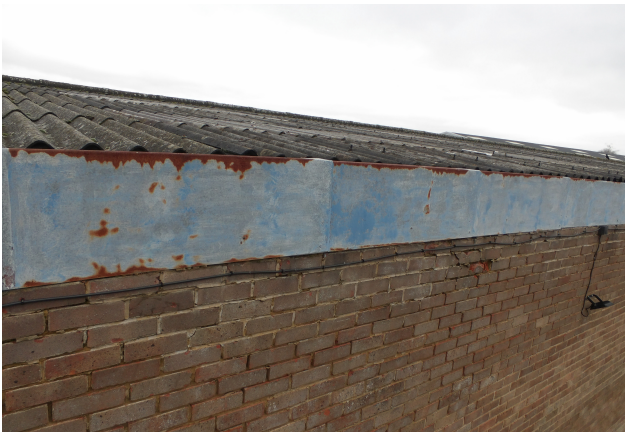
09: Corrosion to metal fascia sheets.

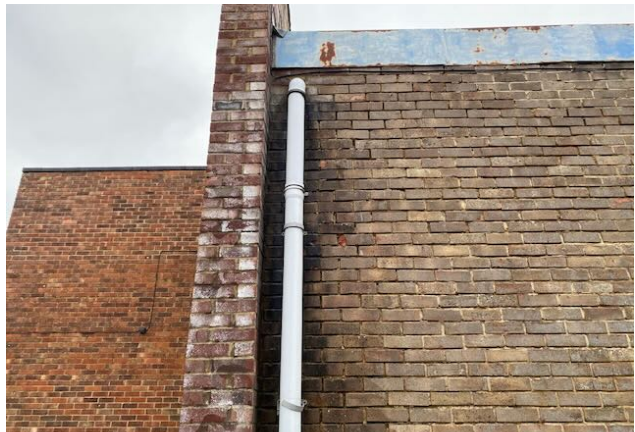
10: Saturated brickwork due to guttering/ downpipe failure.

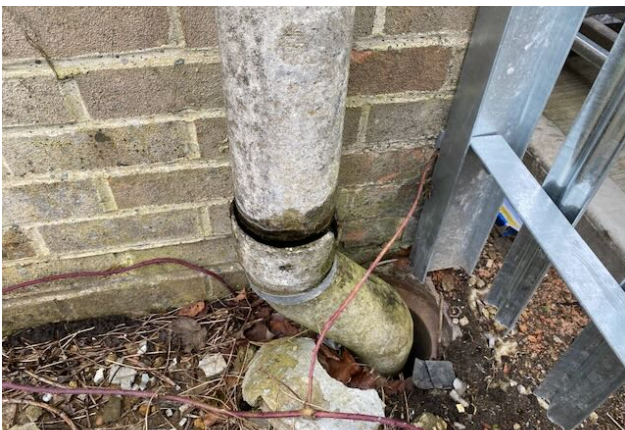
11: Failed downpipes in need of replacement (assumed ACM).

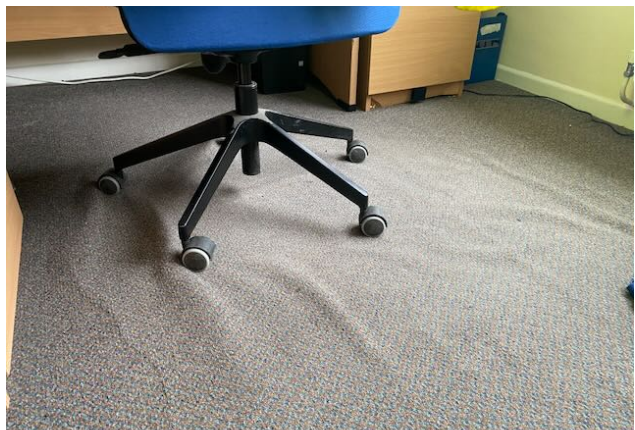
12: Worn/defective carpet to office on first floor.

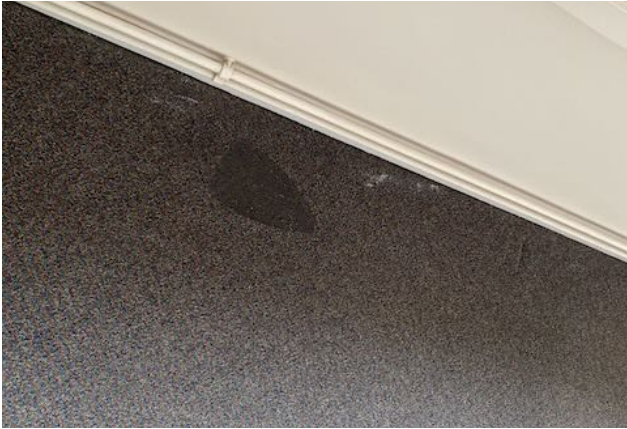
13: Worn/defective carpet to office on first floor.

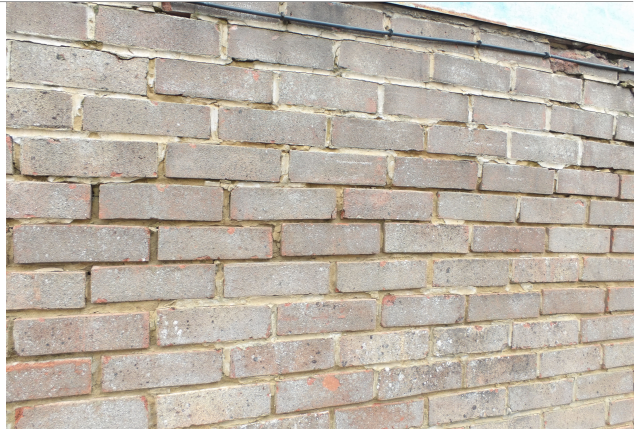
14: Previous repointing works are in poor condition.

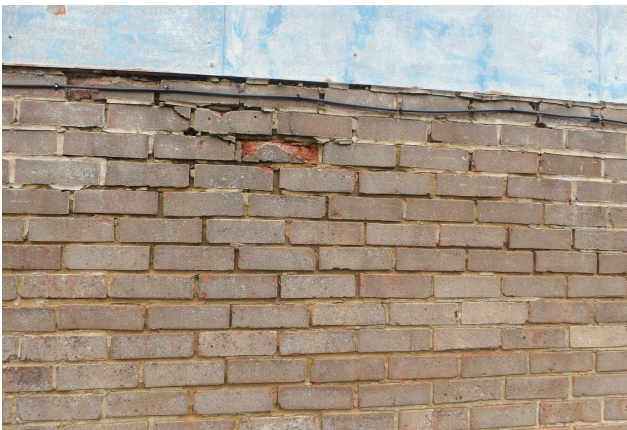
15: Spalling brickwork as a result of failed roof coverings.

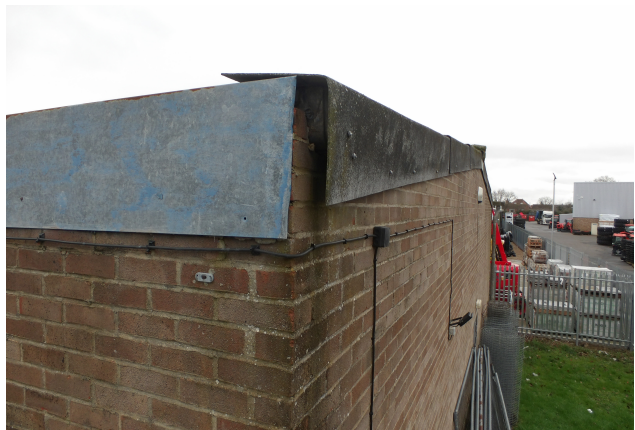
16: Saturated/stained brickwork due to failure in roof drainage.

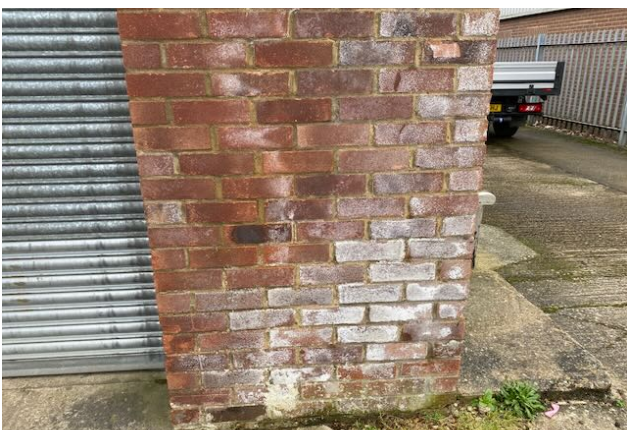
17: Efflorescence evident adjacent to roller shutter.

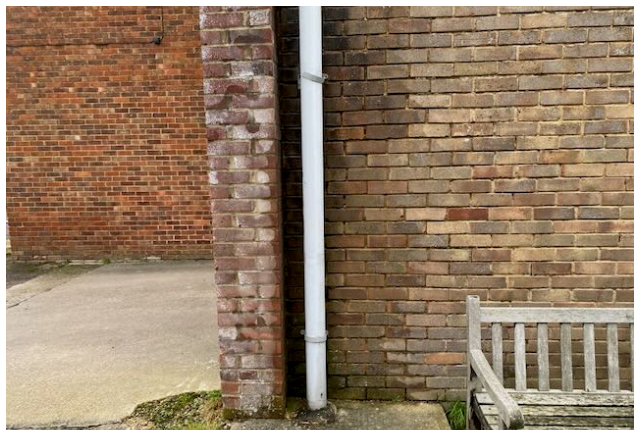
18: Failed rainwater outlet causing saturated brickwork.

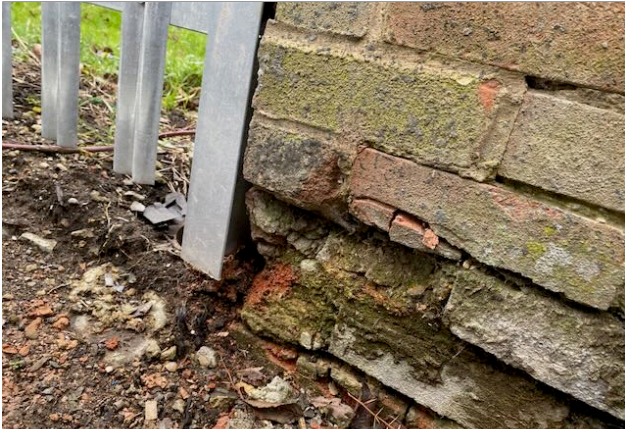
19. Spalled low level brickwork at rear of the warehouse.

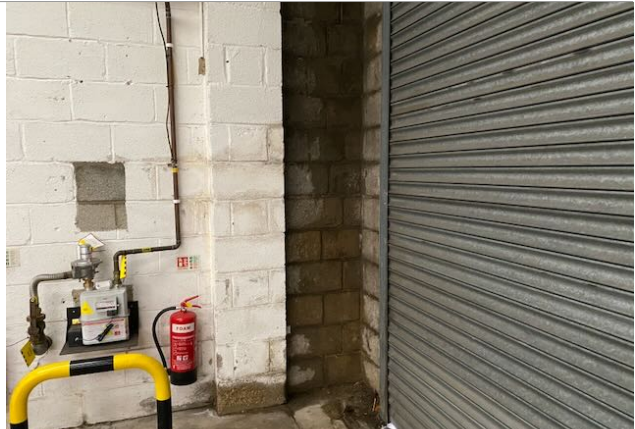
20. Saturated clockwork as a result of failed rainwater outlets.

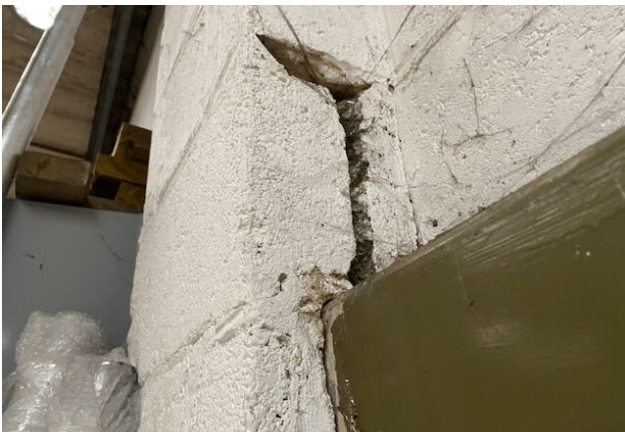
21. Failure of clockwork joints around steel frame.

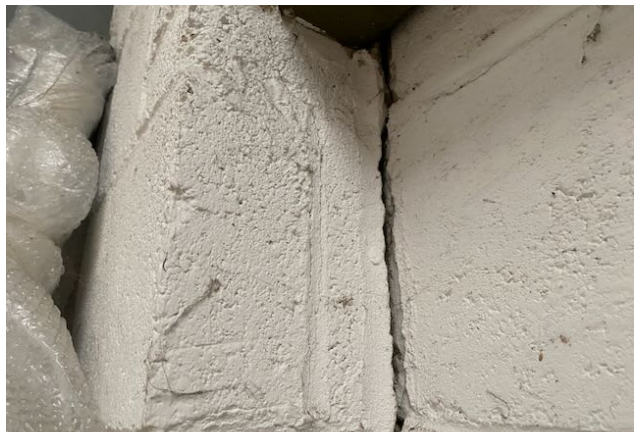
22. Failure of clockwork joints around steel frame.

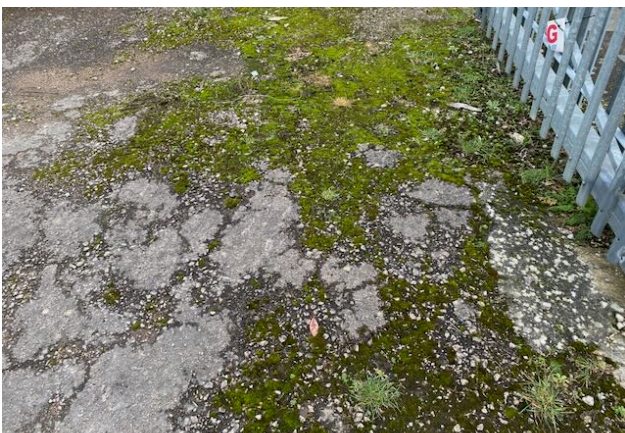
23. Tarmac parking space in poor condition.

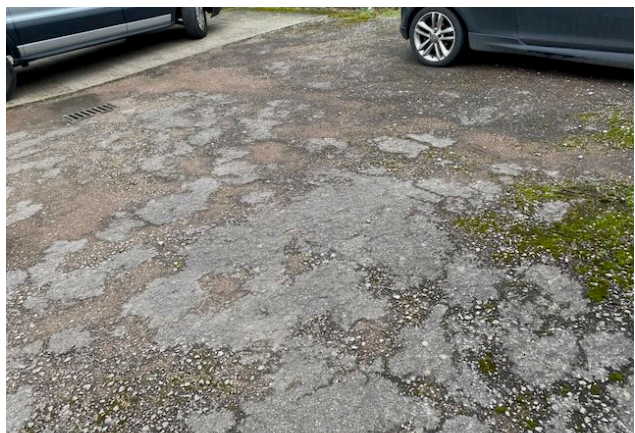
24. Tarmac parking space in poor condition.

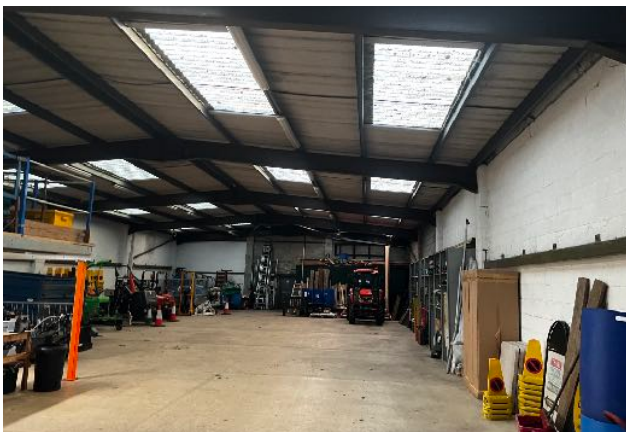
ME01 Warehouse lighting in need of replacement.

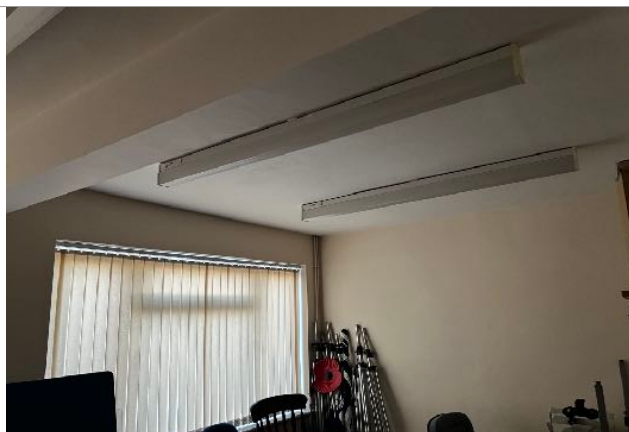
ME02 Office lighting in need of replacement.
